**Flood Control Project Maintenance
Levee Inspections
LMA District Cover Sheet
Spring 2013 Levee Inspection Results**

Reclamation District No. 0765 Glide

Spring 2013 Levee Inspection Results

Waterway		Bank	Unit Miles
Unit No. 01 Sacramento River		Right	1.74

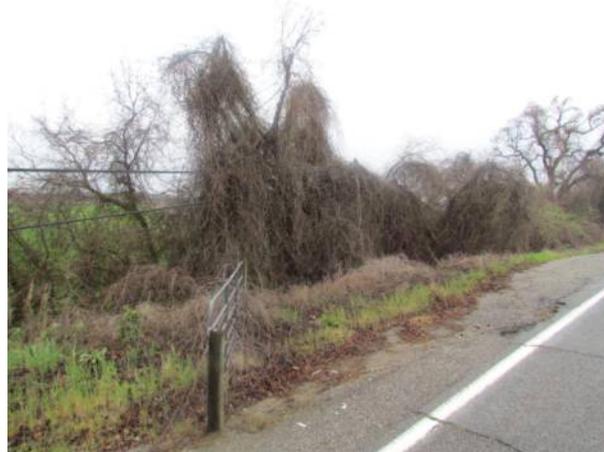
Levee Mile Report Line	30
Start Levee Mile	0.97
End Levee Mile	0.97
Location	Land Side
Category	
Item	Vegetation
Looking northwest at vines on landside toe spring 2012.	
richard_s_20130304_739.jpg

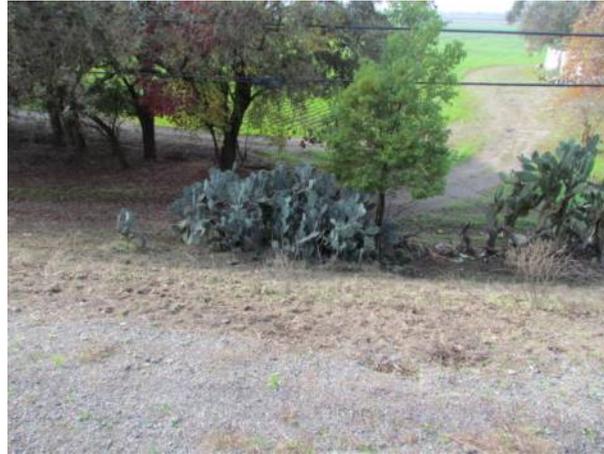
Levee Mile Report Line	34
Start Levee Mile	1.04
End Levee Mile	1.04
Location	Land Side
Category	
Item	Vegetation
Looking west at cactus at landside toe.	
richard_s_20130304_712.JPG

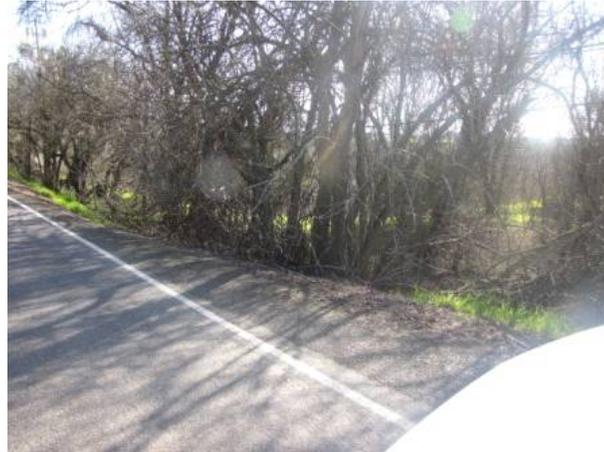
Levee Mile Report Line	35
Start Levee Mile	1.08
End Levee Mile	1.08
Location	Land Side
Category	
Item	Trim / Thin Trees
Looking downstream (southwest) at dense trees on landside slope and toe.	
richard_s_20130304_732.jpg

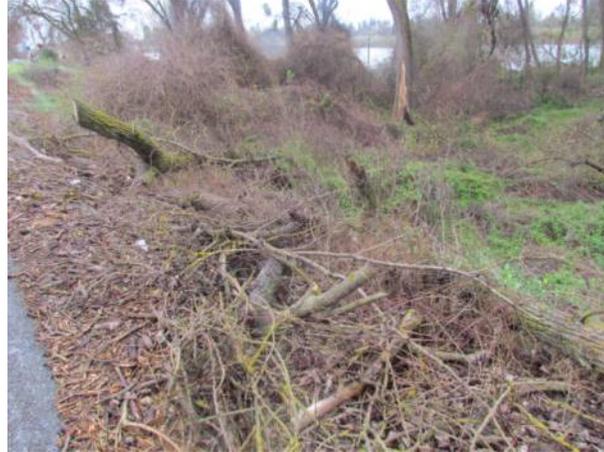
Levee Mile Report Line	41
Start Levee Mile	1.33
End Levee Mile	1.33
Location	Water Side
Category	
Item	Encroachments
Looking northeast at tree limbs on waterside slope.	
richard_s_20130304_717.jpg

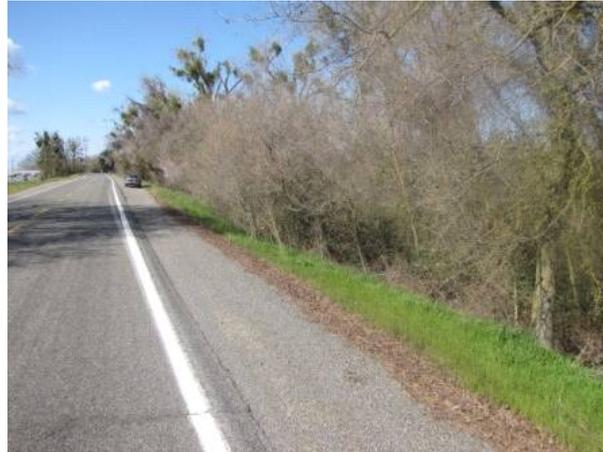
Levee Mile Report Line	44
Start Levee Mile	1.44
End Levee Mile	1.47
Location	Water Side
Category	
Item	Trim / Thin Trees
Looking upstream (north) at dense trees on waterside slope.	
richard_s_20130304_703.jpg

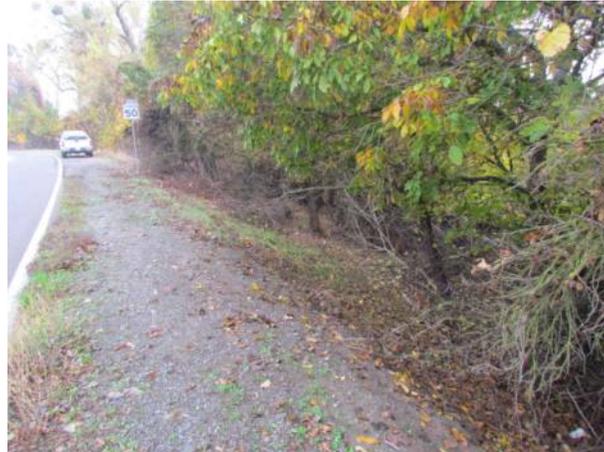
Levee Mile Report Line	47
Start Levee Mile	1.52
End Levee Mile	1.73
Location	Water Side
Category	
Item	Vegetation
Looking north at dense vegetation on waterside slope.	
richard_s_20130304_700.JPG

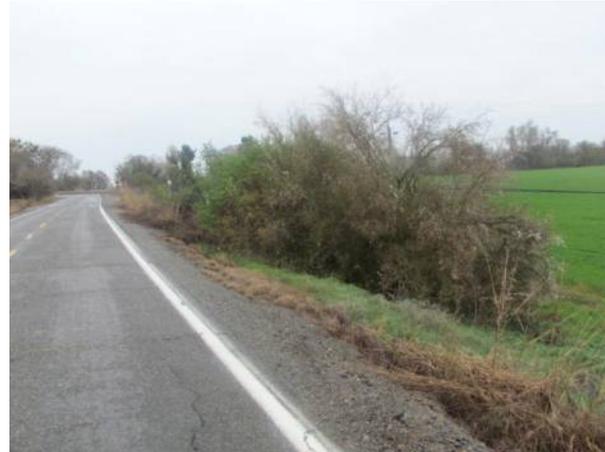
Levee Mile Report Line	48
Start Levee Mile	1.54
End Levee Mile	1.63
Location	Land Side
Category	
Item	Vegetation
Looking south at dense vegetation on landside slope and toe spring 2012.	
richard_s_20130304_721.jpg

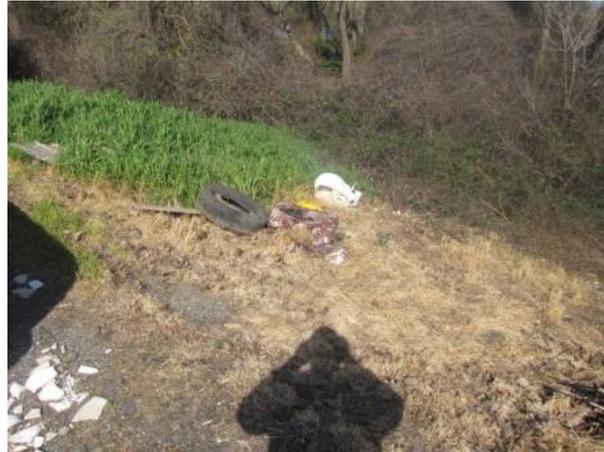
Levee Mile Report Line	51
Start Levee Mile	1.69
End Levee Mile	1.69
Location	Water Side
Category	
Item	Encroachments
Looking northeast at garbage on waterside slope. (May 2011)	
richard_s_20130304_723.jpg

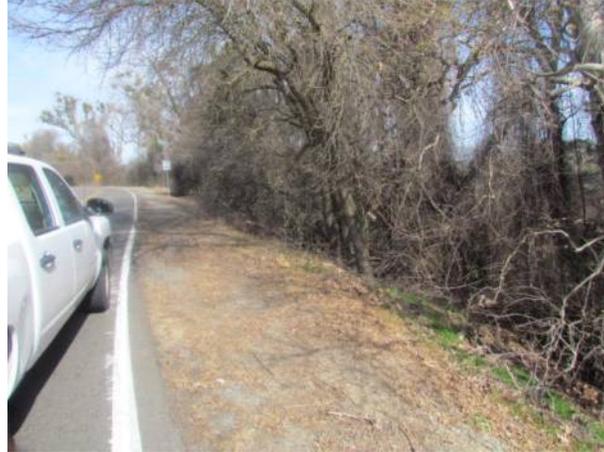
Levee Mile Report Line	53
Start Levee Mile	1.71
End Levee Mile	1.72
Location	Water Side
Category	
Item	Trim / Thin Trees
Looking north (upstream) at dense trees on landside slope.	
richard_s_20130307_982.JPG
